Aussiehome Inspections

Inspection Report

| Date: 5/16/2019 | Time: 7:15 AM | Report ID: |

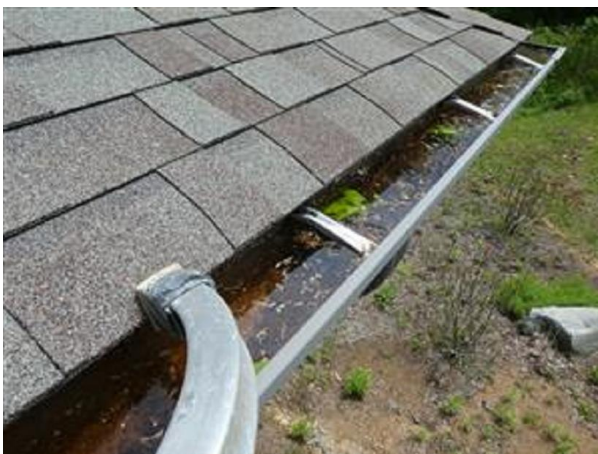
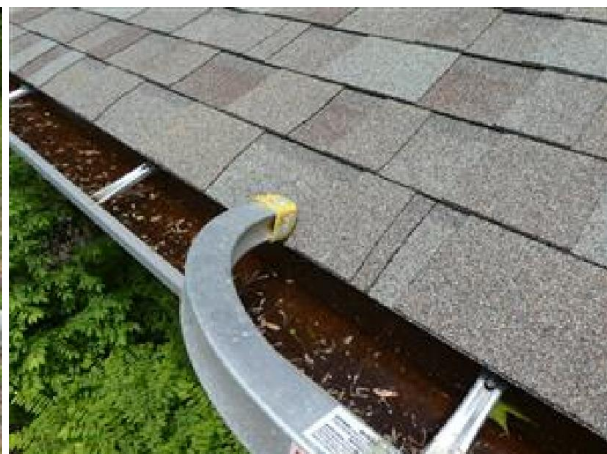
1.2 Picture 1

There is standing water in the right front gutter and also in the back right side gutter. Possibly drainage down spout pipes are blocked up or exit areas for drainage pipes are clogged up.

I recommend somebody qualified evaluate further and repair as necessary so drainage gutters function as intended. Also all remaining gutters should be checked for functional drainage.

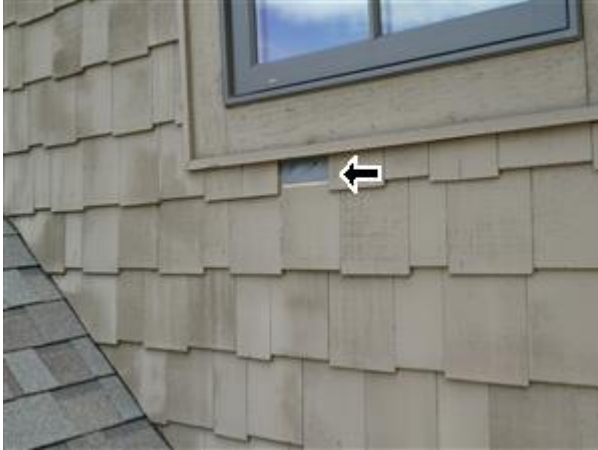
2.0 Picture 1

There is one small siding shingle missing under the side front window that should be replaced before any damage occurs. Recommend somebody qualified make repairs

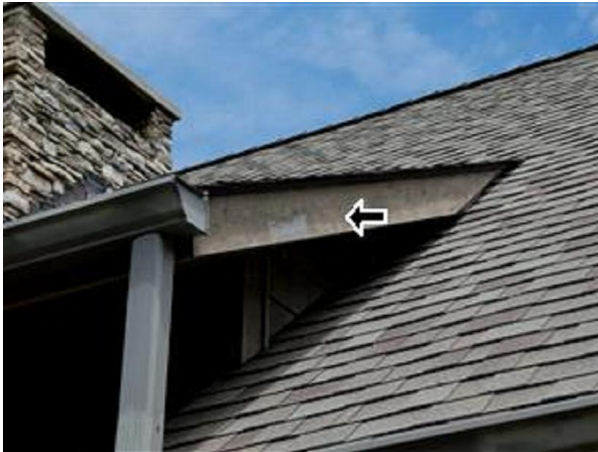
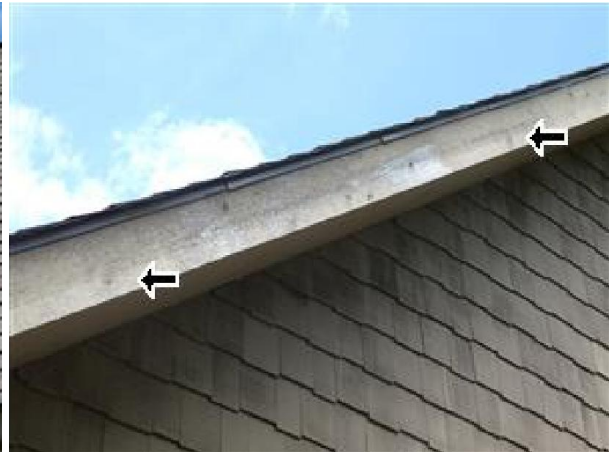
2.4 Picture 1

Fascia boards needs painting on the front of the house before deterioration occurs.

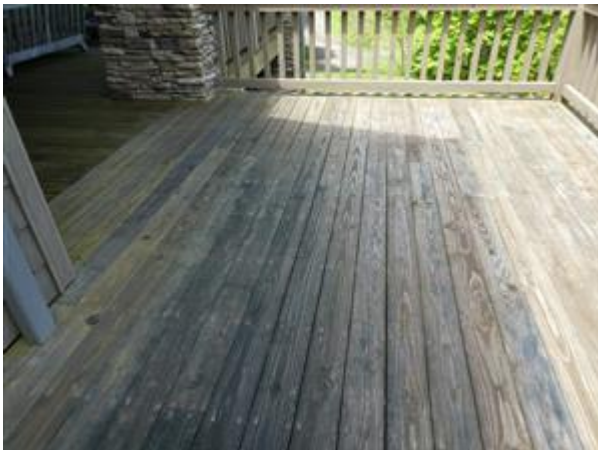
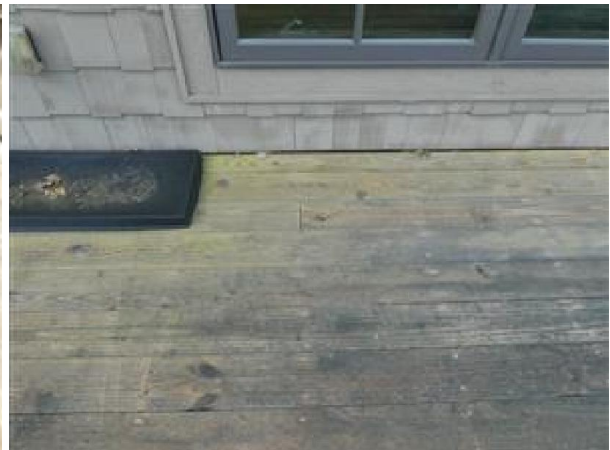
2.5 Picture 1

The back deck area needs a pressure wash and re staining to help prolong the life of this material, and to stop deterioration from occurring.

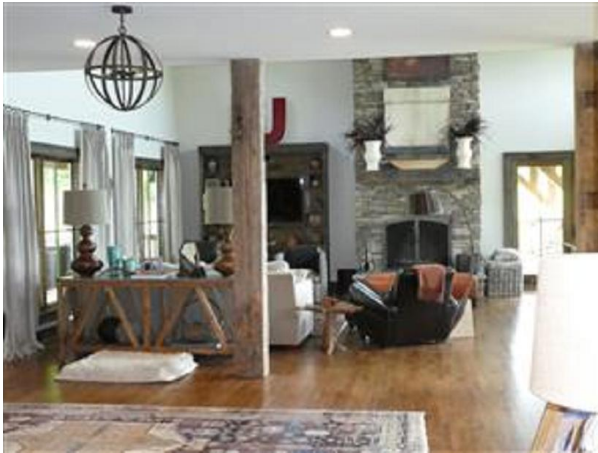
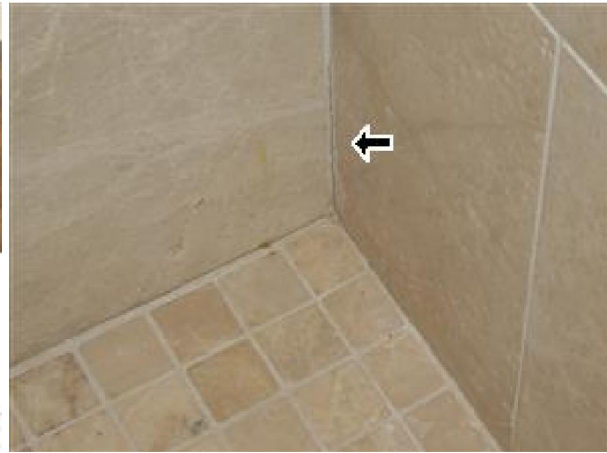
3.2 Picture 1

Tile mortar in the bottom of the shower stall that is cracked in the corner should be re mortared and sealed to ensure there is no water penetration behind or underneath this area.

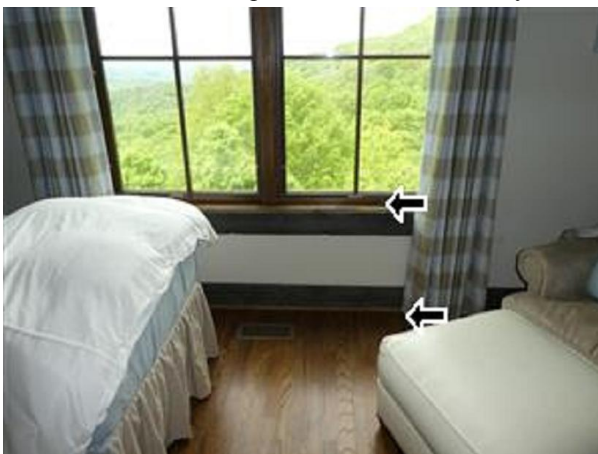
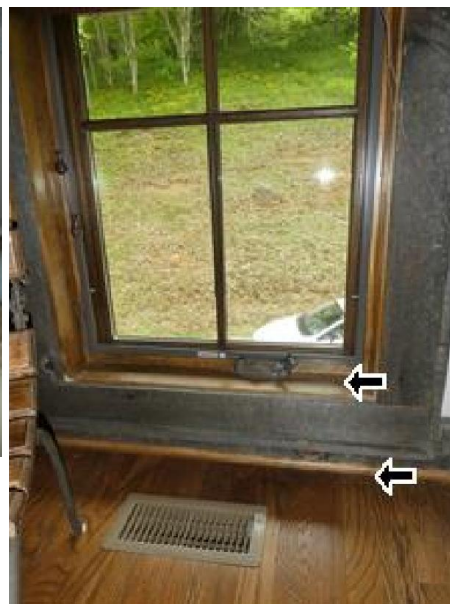
3.6 Picture 1

Modern construction does not allow window clearances from floor to window sills to typically be less than 36 inches. In both of the upstairs bedrooms the distance is less than is usually required. This is a potential safety hazard if a small child were to access open windows even with a screen installed. Security guards on the outside of these windows would be an option for maximum safety.

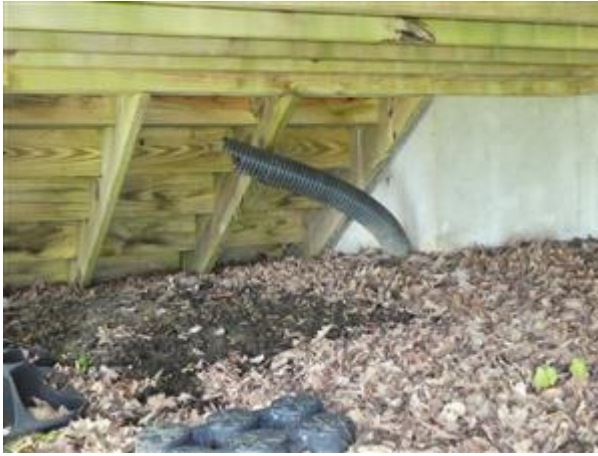
5.0 Picture 1

There is a pipe curled up under the back stairs that I not sure what purpose it is meant to serve. Check with the owner for more information. This may be a foundation drainage pipe that was not installed correctly? There is no evidence of any moisture issues behind this area in the crawl space.

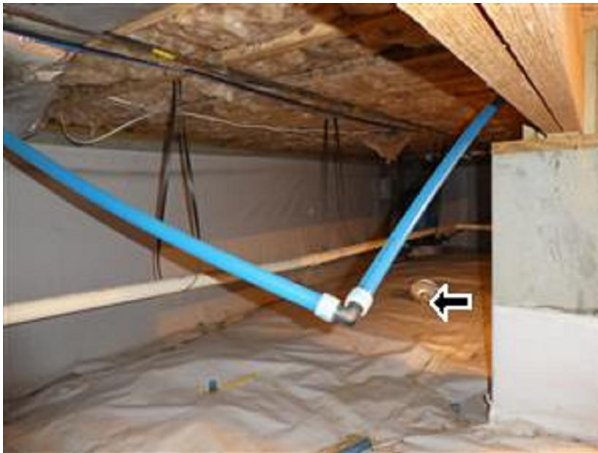
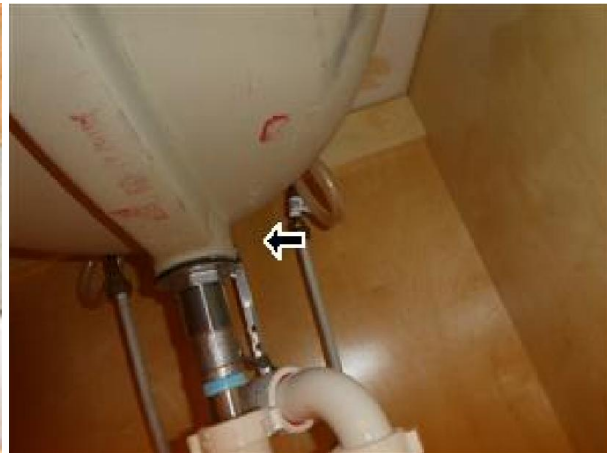
5.1 Picture 1

There is one section of supply plumbing that is not supported in the crawl space. At present the piping is at risk of breaking prematurely. I recommend somebody qualified repair as necessary.

There is a leak under the right side sink in the upstairs bathroom and repairs are necessary. Shutoff valve was turned off after the discovery of leaking.

The left side faucet for the tub downstairs is not installed correctly and needs repair.

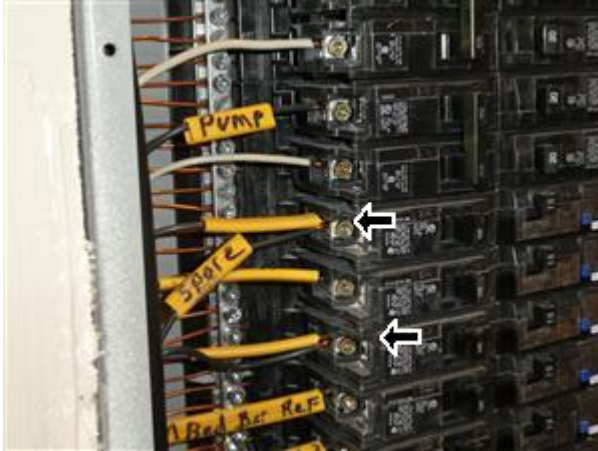
6.2 Picture 1

There is what's called a double tap in the service panel, two wires going into the same breaker.

Double taps are present on two separate breakers.

This is a potential fire hazard and circuit breakers should have only one wire connected . A licensed electrician should rectify this issue.

The service panel does not have a main disconnect breaker. Modern construction does require a main disconnect if you have more then 6 breakers in the service panel.

Shutting off all the power at the service panel ensures and extra margin of safety for electricians that have to work on the panel. I recommend a main shut off breaker be installed by a licensed Electrician.

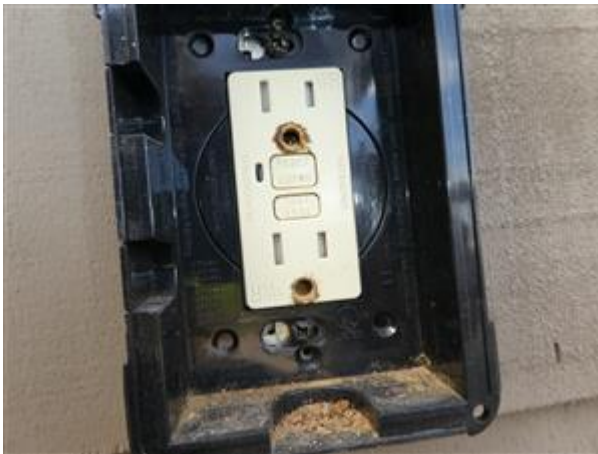
6.4 Picture 1

Two of the outside (Ground Fault Circuit Interrupter outlets on the outside of the house are not installed correctly. Outlets are located on the right side of the house and one on the back right side. I recommend a licensed electrician repair or replace.

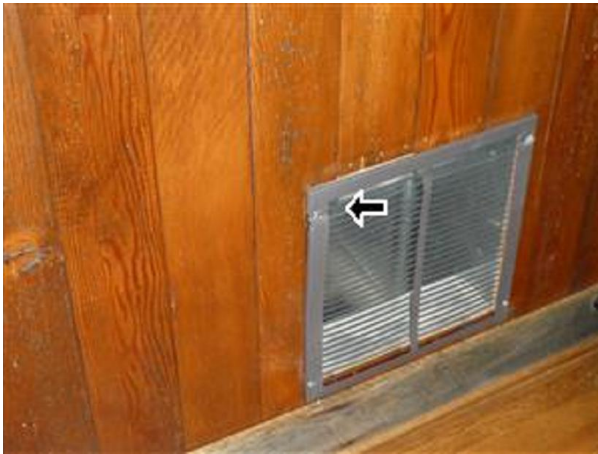
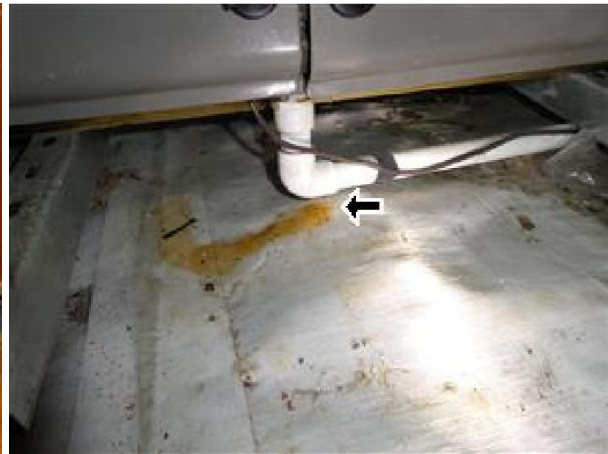
7.0 Picture 1

The condensation drain line for the furnace has a slow leak and needs repair.

Return air register cover in the study is damaged.

I recommend service records be requested from the owner for the heating and cooling system.

If there has not been a service in the last six months I recommend HVAC professional service the system.

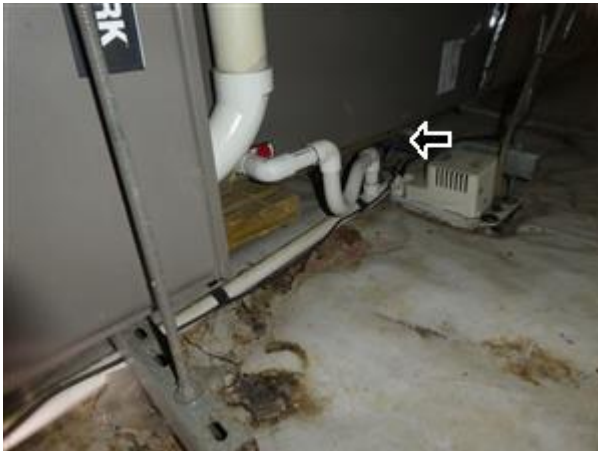
There is no vent connected after the drain trap on the furnace upstairs. This is needed in case the condensation line was to ever clog up, water would not back up into the furnace. This is an easy repair for a Heating Contractor.

7.0 Picture 3 no vent pipe

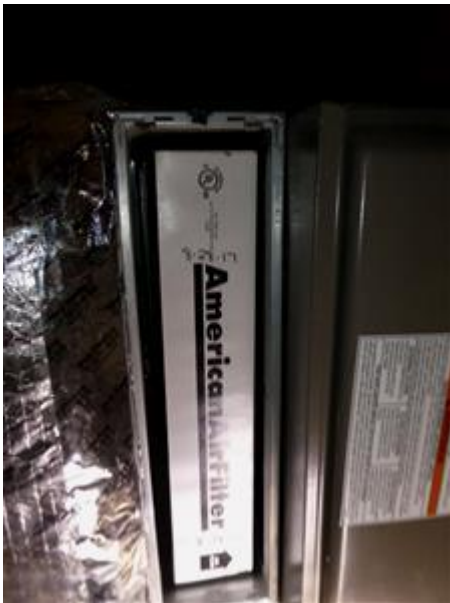
7.3 Picture 1

Filter needs replacing in the furnace in the crawl space. Last one installed in 2017.

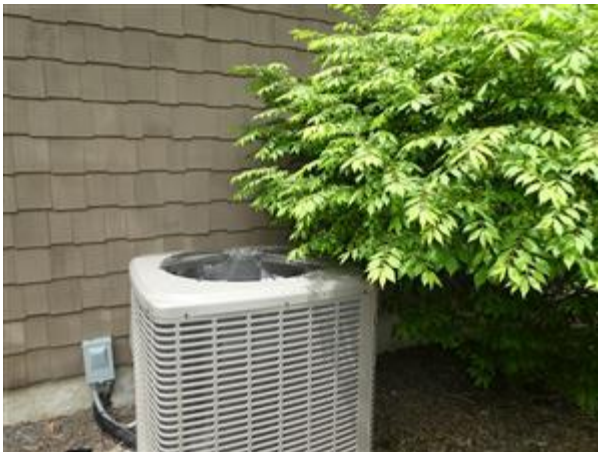
7.8 Picture 1

I recommend cutting back limbs away from the ac unit outside to stop leaf debris from entering the top of the unit which could result in damaging the air handler.

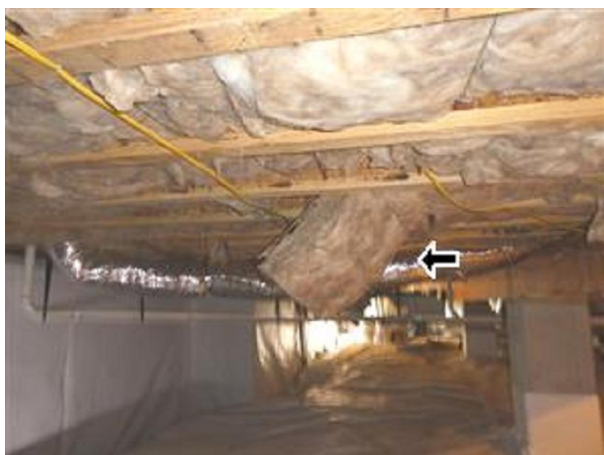
8.1 Picture 1

Insulation is loose in one area and needs to be re secured in place.

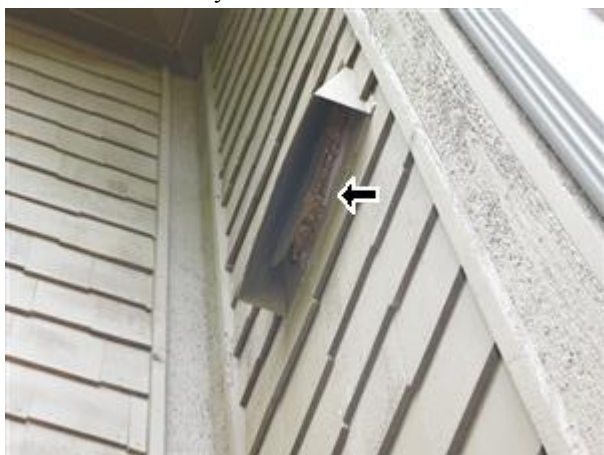
8.4 Picture 1

There is some debris in the exit point outside for the gas range. Debris should be cleaned out so vent works at maximum efficiency.

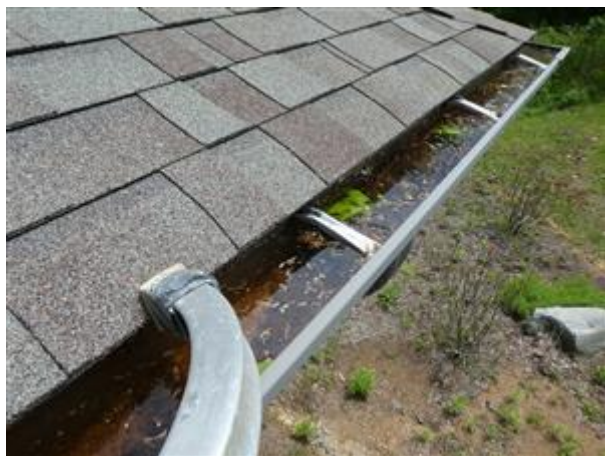
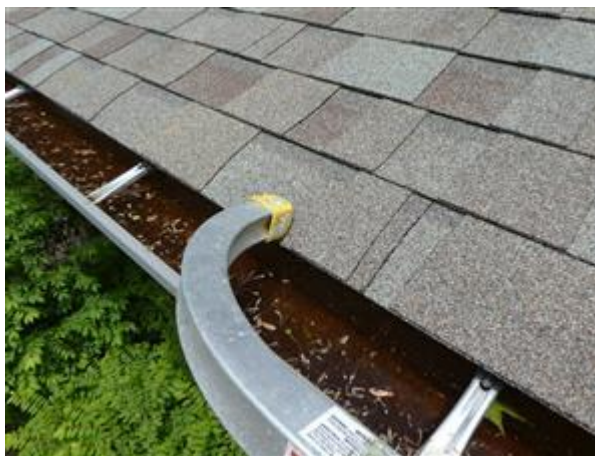
1.2 Picture 1

1.2 There is standing water in the right front gutter and also in the back right side gutter. Possibly drainage down spout pipes are blocked up or exit areas for drainage pipes are clogged up.

I recommend somebody qualified evaluate further and repair as necessary so drainage gutters function as intended. Also all remaining gutters should be checked for functional drainage.

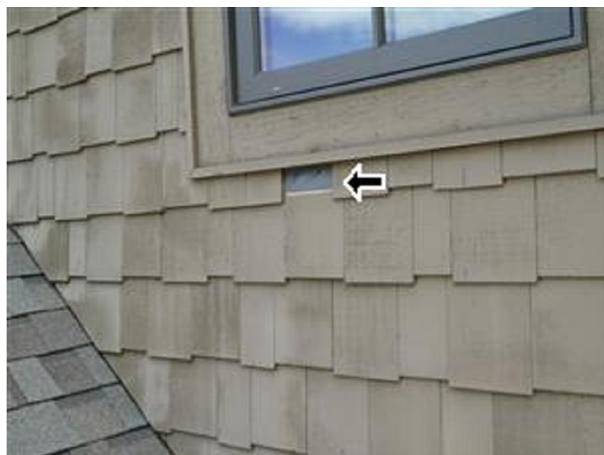
2.0 Picture 1

2.0 There is one small siding shingle missing under the side front window that should be replaced before any damage occurs. Recommend somebody qualified make repairs

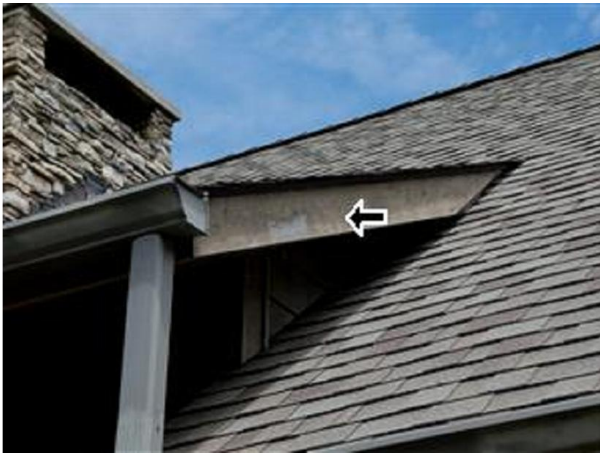
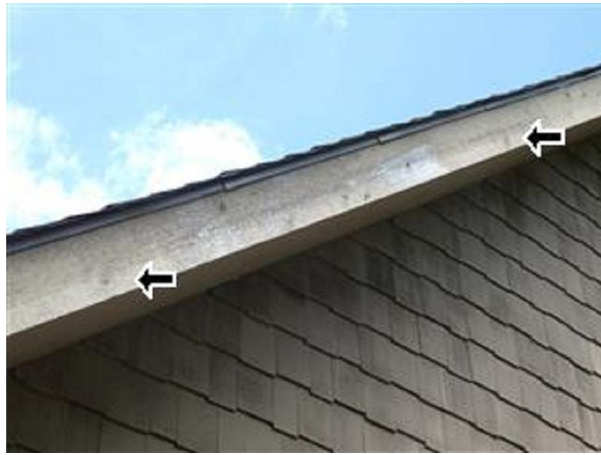
2.4 Picture 1

2.4 Fascia boards needs painting on the front of the house before deterioration occurs.

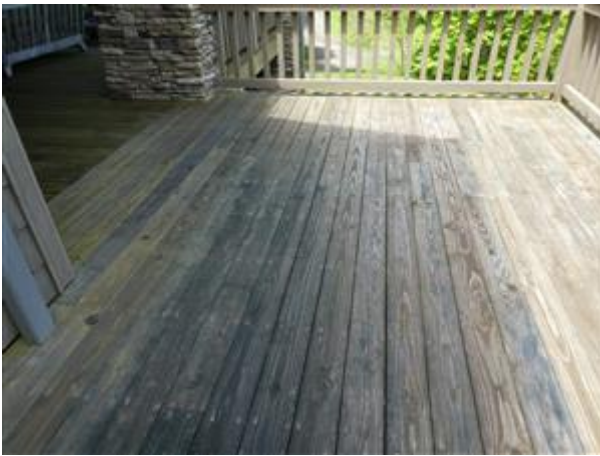
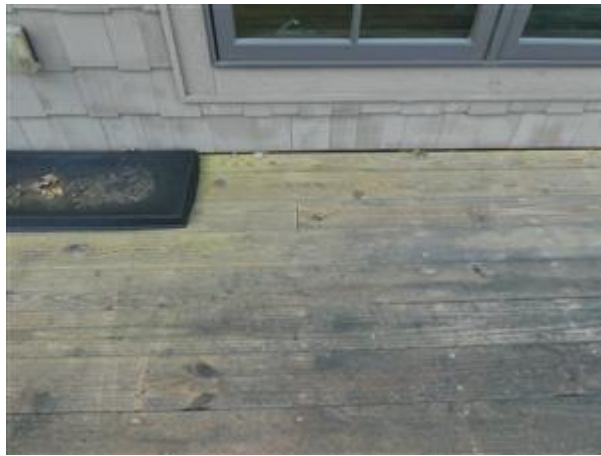
2.5 Picture 1

2.5 The back deck area needs a pressure wash and re staining to help prolong the life of this material, and to stop deterioration from occurring.

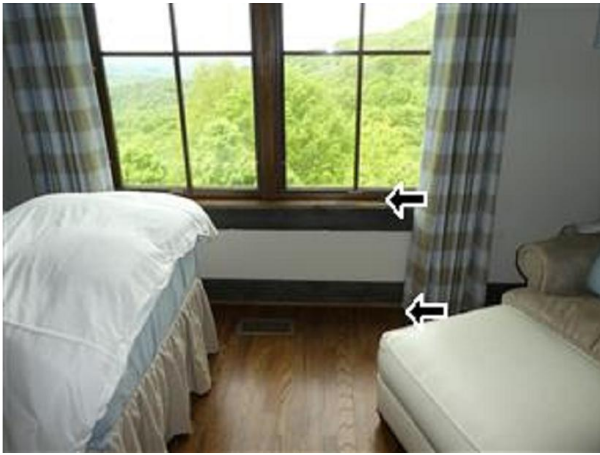
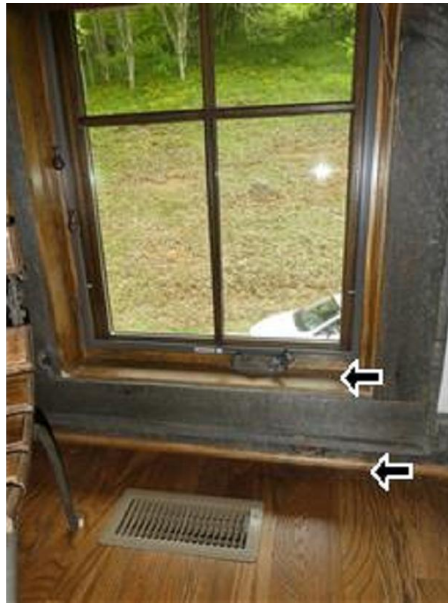
3.6 Picture 1

3.6 Modern construction does not allow window clearances from floor to window sills to typically be less than 36 inches. In both of the upstairs bedrooms the distance is less than is usually required. This is a potential safety hazard if a small child were to access open windows even with a screen installed. Security guards on the outside of these windows would be an option for maximum safety.

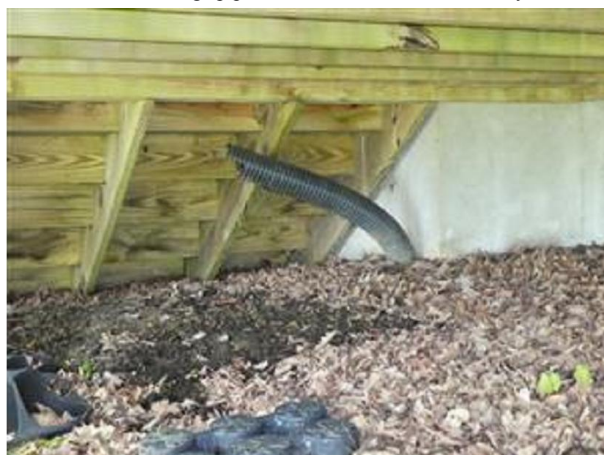
5.0 Picture 1

5.0 There is a pipe curled up under the back stairs that I not sure what purpose it is meant to serve. Check with the owner for more information. This may be a foundation drainage pipe that was not installed correctly? There is no evidence of any moisture issues behind this area in the crawl space.

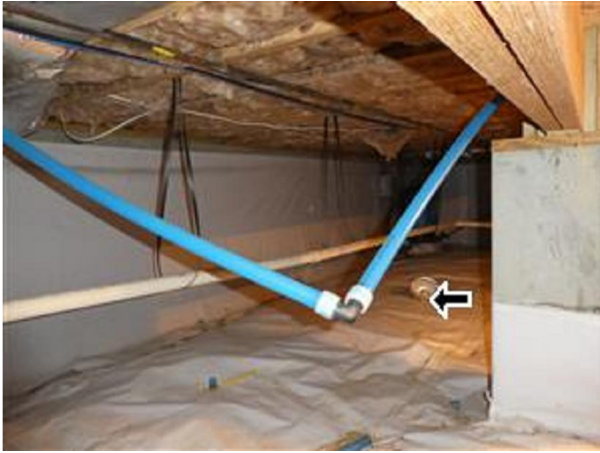
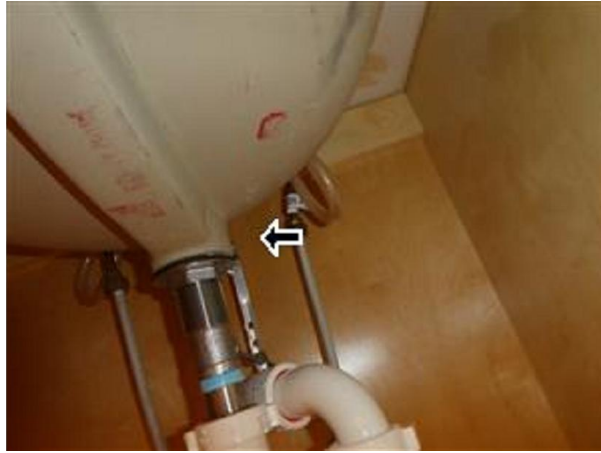
5.1 Picture 1

5.1 There is one section of supply plumbing that is not supported in the crawl space. At present the piping is at risk of breaking prematurely. I recommend somebody qualified repair as necessary.

There is a leak under the right side sink in the upstairs bathroom and repairs are necessary. Shutoff valve was turned off after the discovery of leaking.

The left side faucet for the tub downstairs is not installed correctly and needs repair.

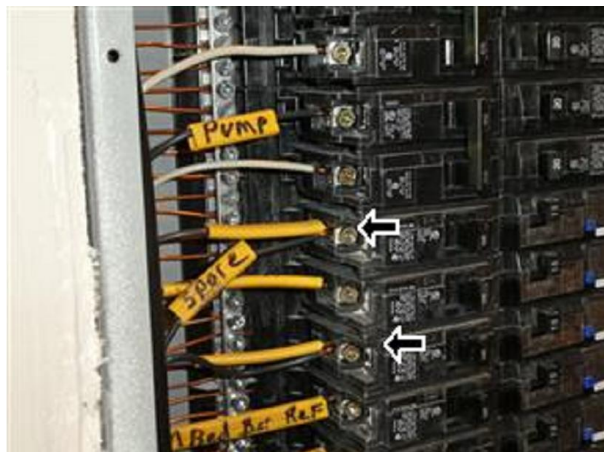
6.2 Picture 1

This is a potential fire hazard and circuit breakers should have only one wire connected . A licensed electrician should rectify this issue.

The service panel does not have a main disconnect breaker. Modern construction does require a main disconnect if you have more then 6 breakers in the service panel.

Shutting off all the power at the service panel ensures an extra margin of safety for electricians that have to work on the panel. I recommend a main shut off breaker be installed by a licensed Electrician.

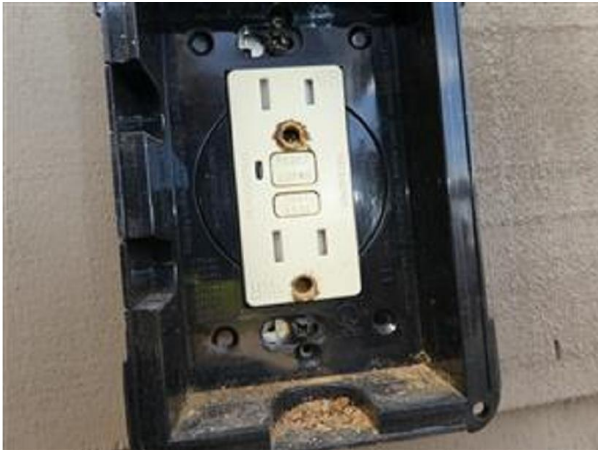
6.4 Picture 1

6.4 Two of the outside (Ground Fault Circuit Interrupter outlets on the outside of the house are not installed correctly. Outlets are located on the right side of the house and one on the back right side. I recommend a licensed electrician repair or replace.

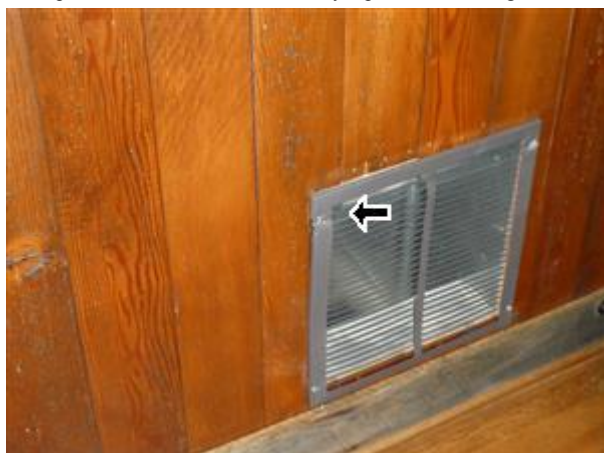
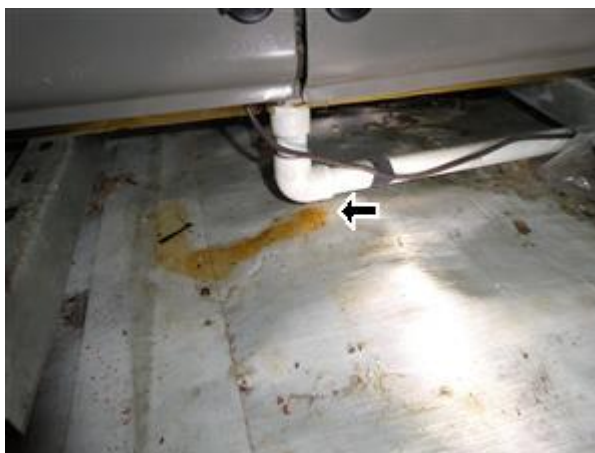
7.0 Picture 1

7.0 The condensation drain line for the furnace has a slow leak and needs repair.

Return air register cover in the study is damaged.

I recommend service records be requested from the owner for the heating and cooling system.

If there has not been a service in the last six months I recommend HVAC professional service the system.

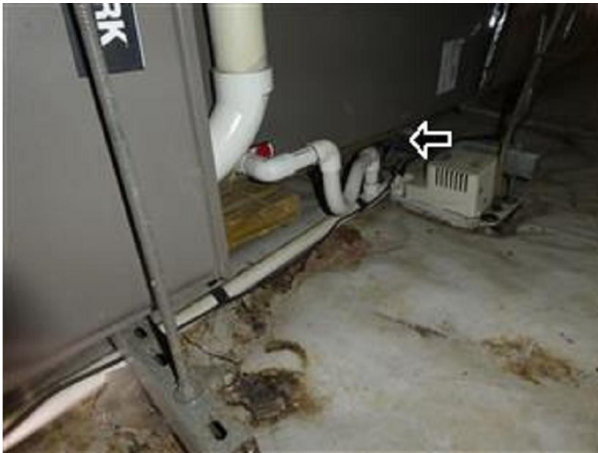
There is no vent connected after the drain trap on the furnace upstairs. This is needed in case the condensation line was to ever clog up, water would not back up into the furnace. This is an easy repair for a Heating Contractor.

7.0 Picture 3 no vent pipe

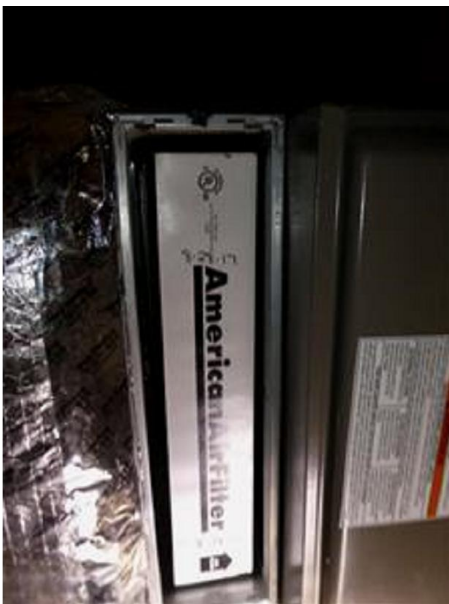
7.3 Picture 1

7.3 Filter needs replacing in the furnace in the crawl space. Last one installed in 2017.

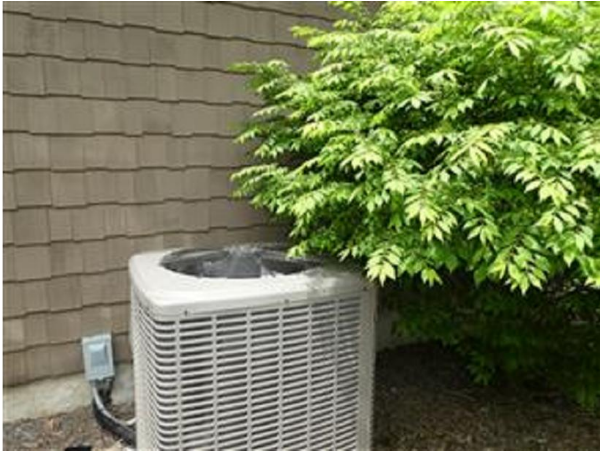
7.8 Picture 1

7.8 I recommend cutting back limbs away from the ac unit outside to stop leaf debris from entering the top of the unit which could result in damaging the air handler.

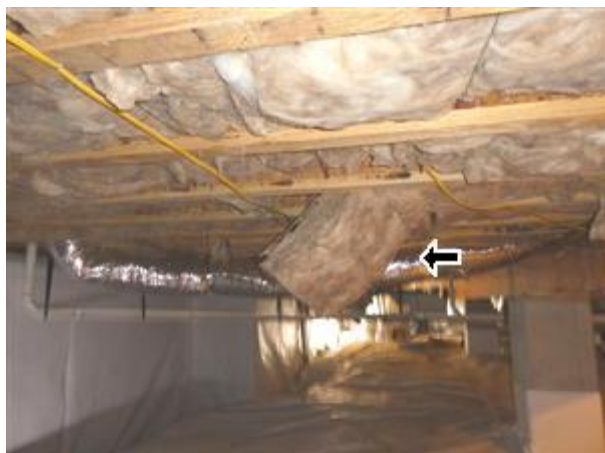
8.1 Picture 1

8.1 Insulation is loose in one area and needs to be re secured in place.

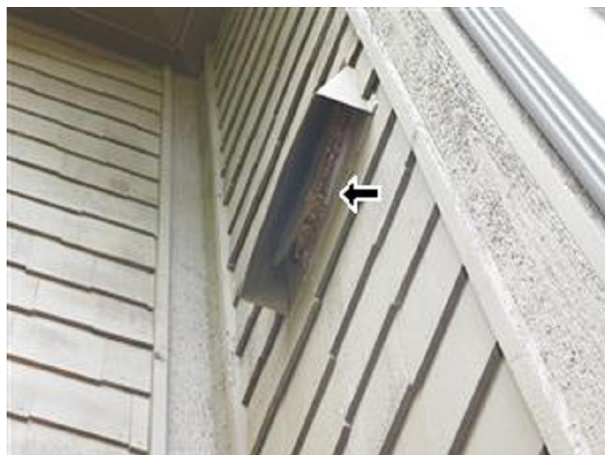
8.4 Picture 1

8.4 There is some debris in the exit point outside for the gas range. Debris should be cleaned out so vent works at maximum efficiency.
